BYLAW NO. 209

**Being a Bylaw in the Town of Banff in the Province of Alberta
to designate the Luxton Residence as a Municipal Historic Resource**

SCHEDULE “A” TO BYLAW NO. 209

THE IDENTIFICATION OF REGULATED PORTIONS OF THE LUXTON RESIDENCE

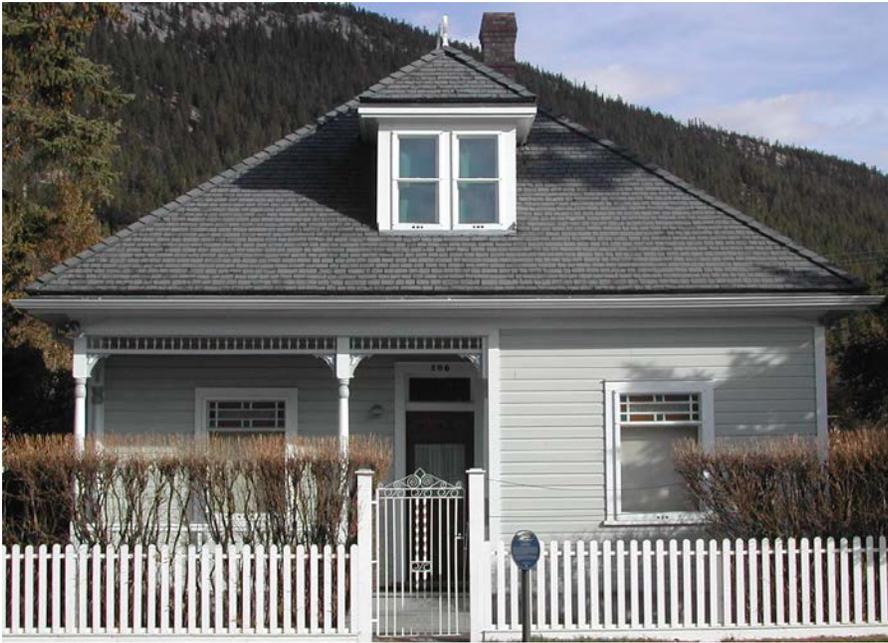
Photo 1 – North façade

- Front façade clad in painted horizontal wood siding with corner boards and trim (photo 1);
- Steeply pitched hipped roof, hipped roof dormer and decorative roof cresting (photos 1 & 2);
- Double window opening in hipped roof dormer (photo 2);
- Roof and dormer walls clad in cedar shingles (photo 2);
- Partial front entrance porch integral to roof with Queen Anne detailing (photos 3 & 4);
- Centered wood door with window immediately above door opening (photos 1 & 3);
- Single window opening with stained glass on each side of door (photos 1 & 5);

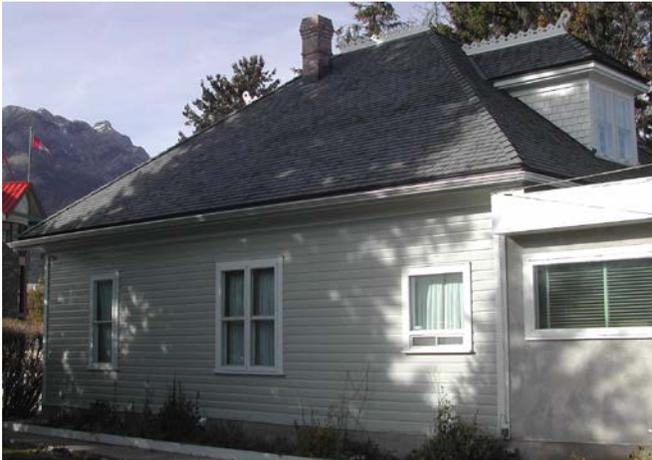
Photo 6 – South façade

- South façade clad in painted horizontal wood siding with corner boards and trim (photo 6);
- Steeply pitched hipped roof clad in cedar shingles and decorative roof cresting (photos 6 & 7);
- Three window openings on original building (photo 6);

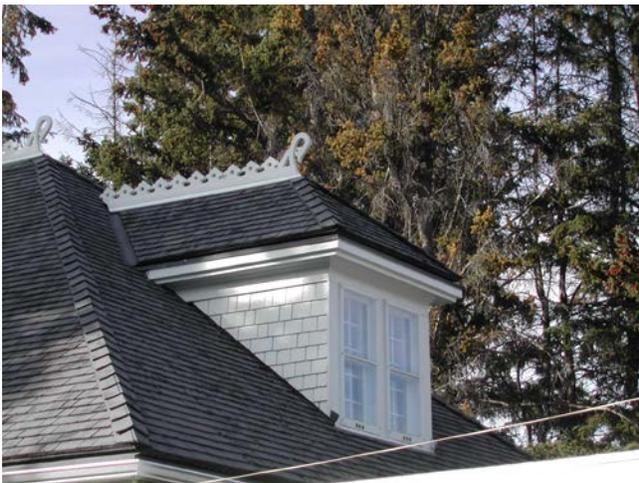
Photo 8 – Dormer detail (east)

- Steeply pitched hipped roof of original building, hipped roof dormer and decorative roof cresting (photo 8);
- Double window opening in hipped roof dormer (photo 8);
- Roof and dormer walls clad in cedar shingles (photo 8);

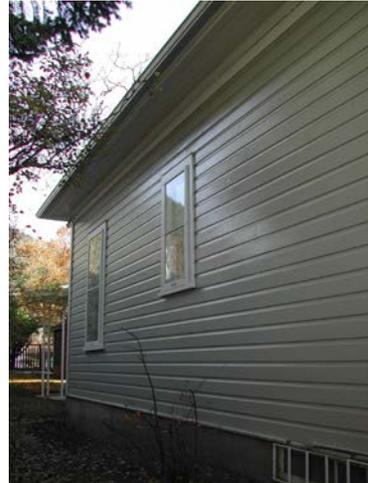
Photo 9 – North façade

- North façade clad in painted horizontal wood siding with corner boards and trim (photo 9);
- Steeply pitched hipped roof clad in cedar shingles and decorative roof cresting;
- Two window openings (photo 9);

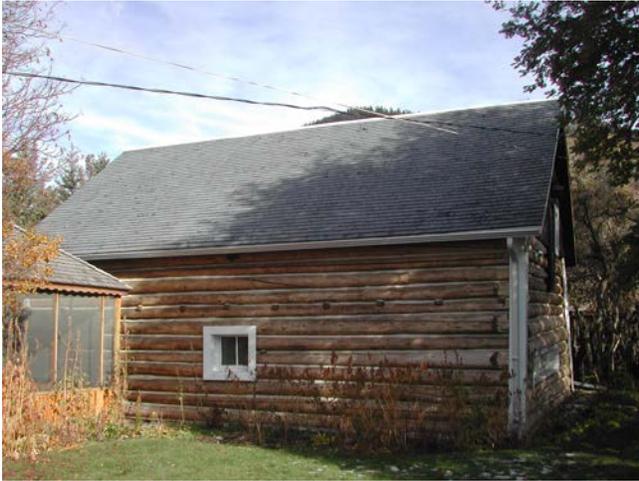
Photo 10 – West façade of stable/garage

- Restored horizontal log wall with vertical corner boards, single window opening and shingled gable roof (photos 10 & 11);

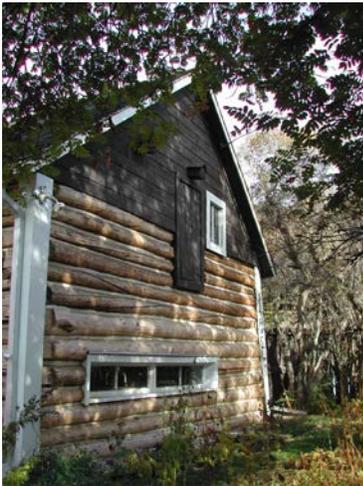
Photo 12 – South façade

- Restored horizontal log wall with vertical corner boards and window opening (photo 12);
- Gable end clad in horizontal wood siding with loft door and window opening (photo 13);

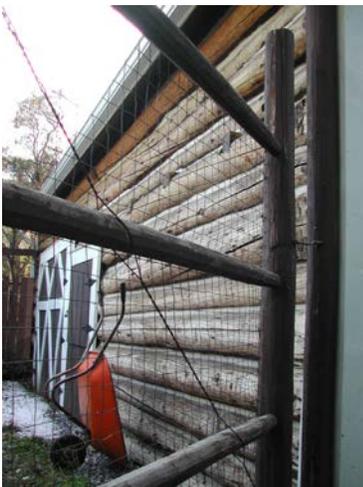
Photo 14 – East façade

- Restored horizontal log wall with vertical corner boards, one double door opening and one single door opening and shingled gable roof (photos 14 & 15);

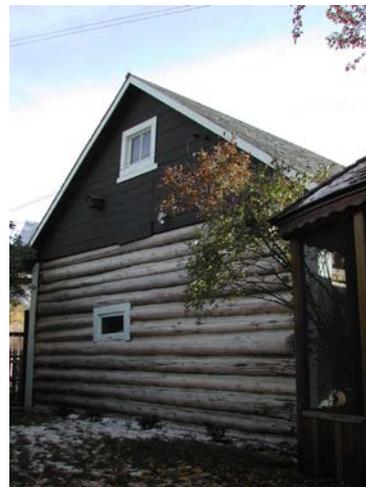
Photo 16 – North façade

- Restored horizontal log wall with vertical corner boards and two window openings (photo 16);
- Gable end clad in horizontal wood siding (photo 16);
