### **3.5 Land Use**

#### **3.5.1 Historical Land Use**

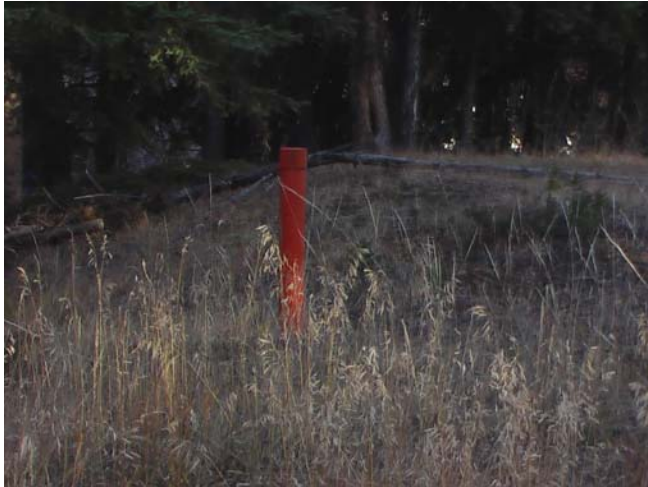
Photo 27 – Monitoring well on CP Rail site at the existing recreation centre site.

On the CP Rail lands there are several monitoring wells (Photo 27). Data from the groundwater has been collected from these monitoring wells for a number of years. From past land use on the CP Rail site, such as fuel tank storage by Imperial Oil, there is potential for contamination on the site (EBA 2007a). Information regarding the monitoring data and the length of time the monitoring wells have been in place is unavailable. CP Rail will not provide any relevant environmental data due to a potential transaction between Parks Canada and CP Rail (Ahmed Ezzat, CP Rail Environmental Staff Consultant, pers. comm. 2007).

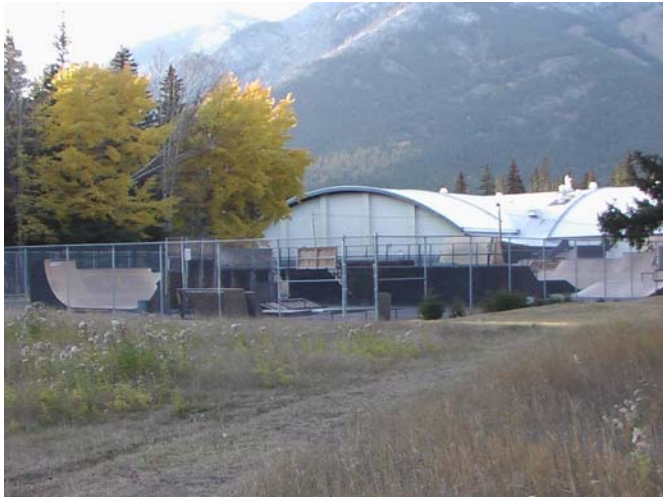
Photo 29 – Skatepark and recreation centre.

The existing recreation centre is located in the southwest end of the site and occupies a footprint of approximately 11,000 m<sup>2</sup> (EBA, 2007). Within the footprint is a building, built in 1961 and further developed in 1968 that contains a full size ice hockey rink as well as a junior rink and four curling rinks. There are viewing galleries, a lounge with a seating capacity of 165, change rooms, and supporting mechanical services for the maintenance of the ice surfaces within the building. Within the exterior footprint of the complex there are three parking areas; a skateboard park that covers the previous tennis courts (Photo 29); a storage shed; maintenance shed and associated works yard with equipment and building supplies and a cleared area to be used as an ice skating surface for the winter of 2007/2008. The access road to this facility is from Mount Norquay Road.

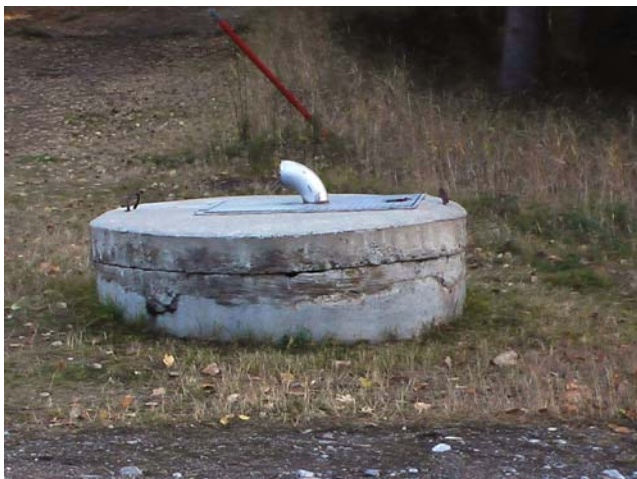
Photo 30 – Sewage lift station at the existing recreation centre site.

There is a cleared ROW that extends from the hockey arena, parallel to Mt. Norquay Road, to the edge of the CP Rail lands. This ROW is for the municipal sewer line and has a sewage lift station at the end where it intersects the recreation centre parking lot (photo 30).

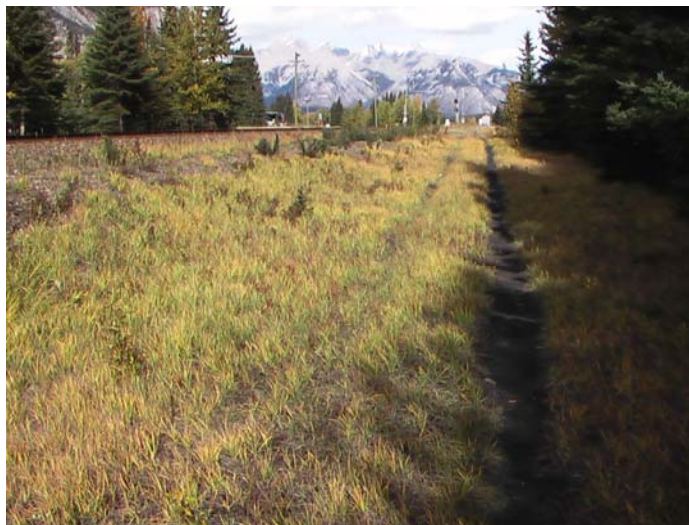
Photo 31 – Pedestrian/cycling trail and single set of railway tracks at Elkwoods site.

The site is bordered to the northwest by the CP Rail ROW that contains a pedestrian/cycling trail and a single set of tracks (photo 31) and to the northeast by Compound Rd. The southeast boundary of the site is defined by Banff Avenue and the southwest boundary by the residences and businesses on the northeast side of Marmot Crescent.

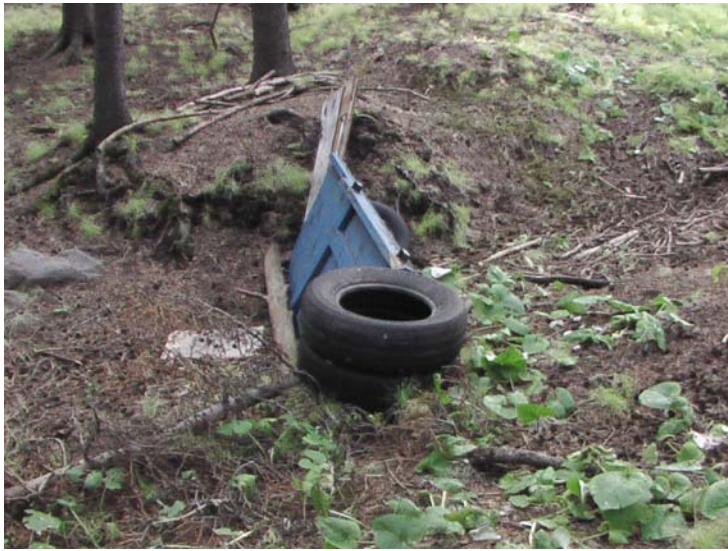
Photo 32 – Garbage on site, attempt at small dam at Elkwoods site.

The portion of the site southwest of ROW 2 has very little evidence of human use. There is one area that has a dam made of wood and tires across an ephemeral channel (photo 32) and a dump of household goods.
