BYLAW NO. 210

**Being a Bylaw in the Town of Banff in the Province of Alberta
to designate Tanglewood as a Municipal Historic Resource**

SCHEDULE “A” TO BYLAW NO. 210

THE IDENTIFICATION OF REGULATED PORTIONS OF TANGLEWOOD

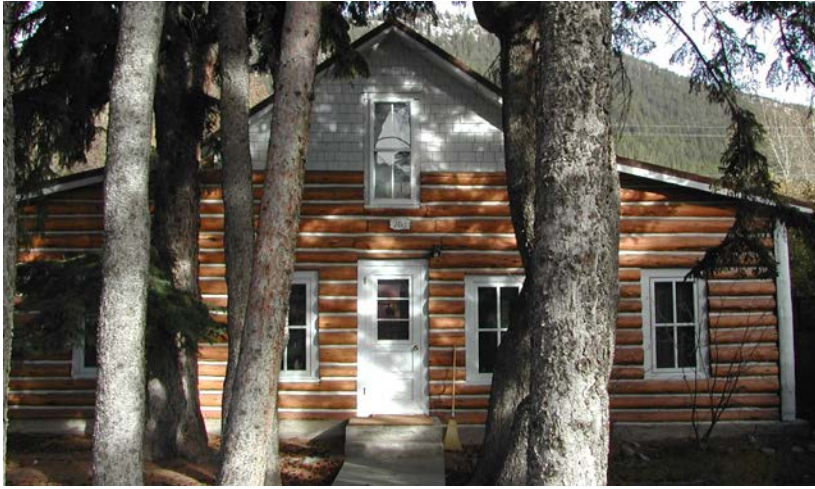
Photo 1 – West façade

- Front façade clad in horizontal half log veneer siding with vertical corner logs (photo 1 & 2);
- Gable roof end with painted wood sidewall shingles above the log veneer siding and single window opening over door (photo 3);
- Central front entrance and inset door opening (photo 1 & 3);
- Two inset window openings on each side of the door (photo 1, 3 & 6);

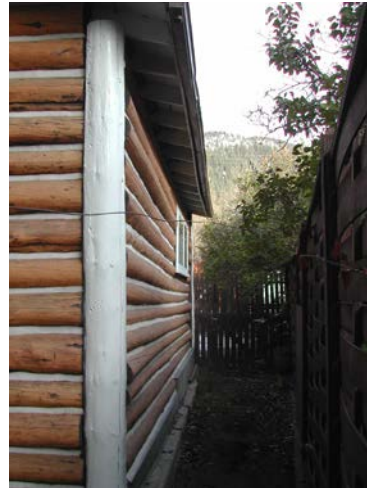
Photo 4 – South façade

- South façade clad in horizontal half log veneer siding with vertical corner logs, single window opening and exposed rafter ends (photo 4 & 5);

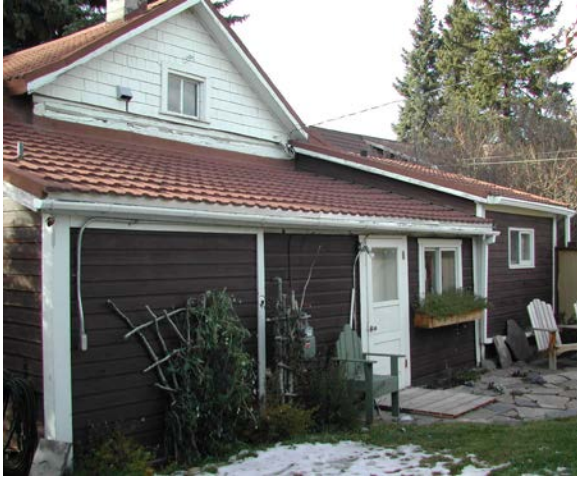
Photo 7 – East façade

- Gable roof end of original structure with painted wood sidewall shingles and single window opening (photo 7 & 8);

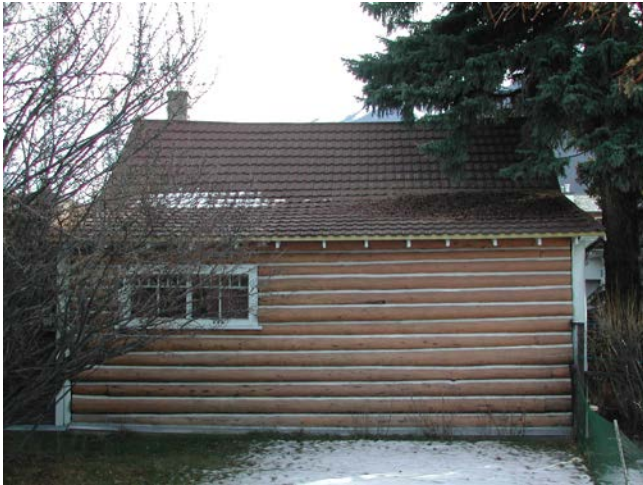
Photo 9 – North façade

- North façade clad in horizontal half log veneer siding with vertical corner logs, single window opening and exposed rafter ends (photo 9, 10 & 11);
