BYLAW NO. 217

Being a Bylaw to designate the Dave White Block as a Municipal Historic Resource

SCHEDULE “A” TO BYLAW NO. 217

THE IDENTIFICATION OF REGULATED PORTIONS OF THE DAVE WHITE BLOCK

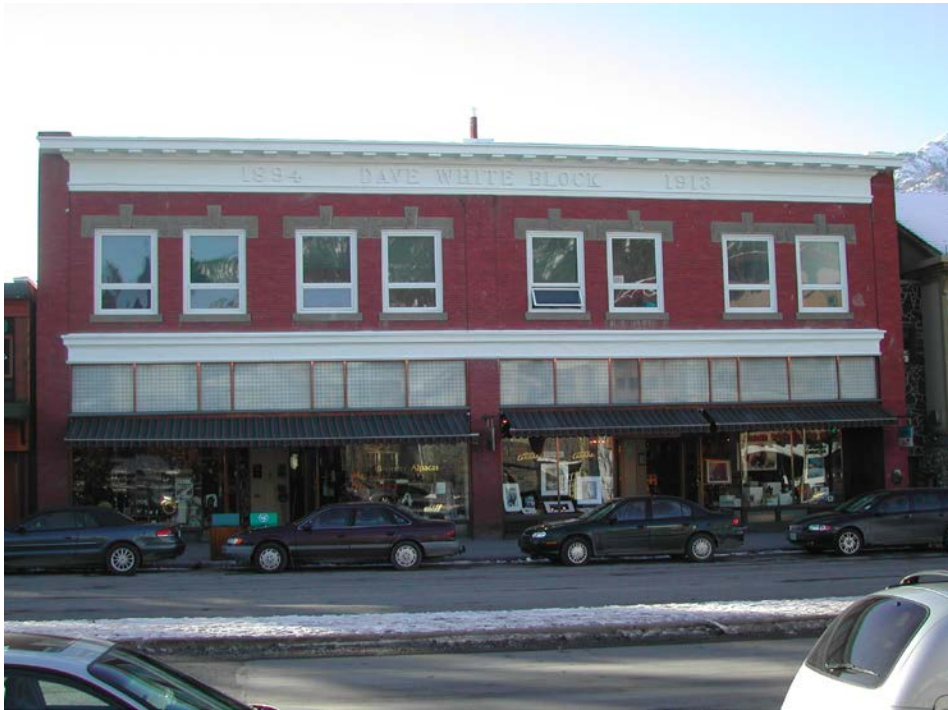
Photo 1 – front façade

- The two-storey front façade clad in red brick (photo 1);
- Series of paired second storey window openings, including the position, number, size and arrangement, with stone detailing on head and sill (photos 1, 2, 3 & 6);

- Flat roof with metal cornice and white frieze band imprinted with building name and dates of construction “1894 Dave White Block 1913” (photos 1, 4, 5 & 6);

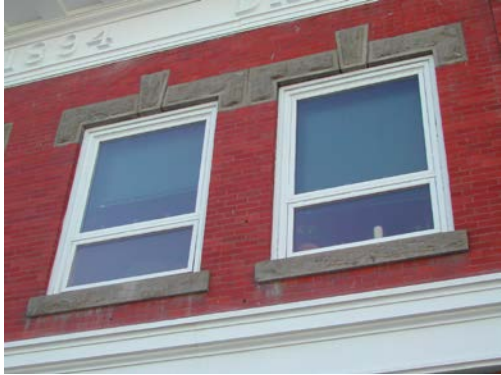
Photo 2 – second storey window detail

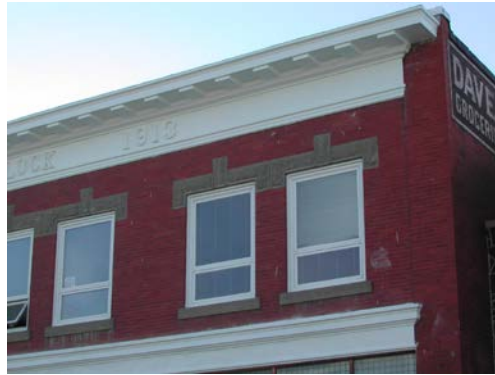
Photo 3 – second storey window detail

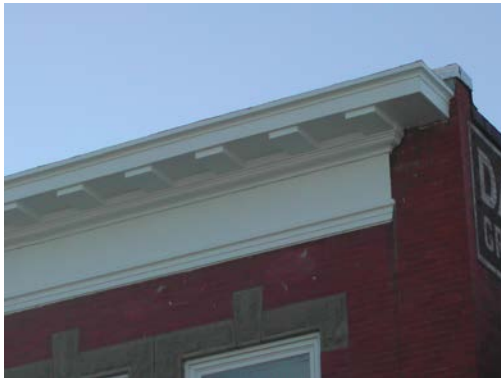
Photo 4 – cornice detail

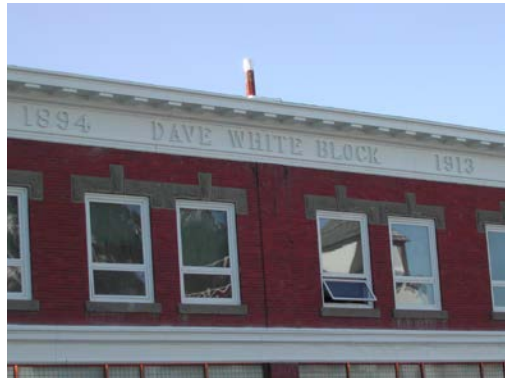
Photo 5 – frieze band detail

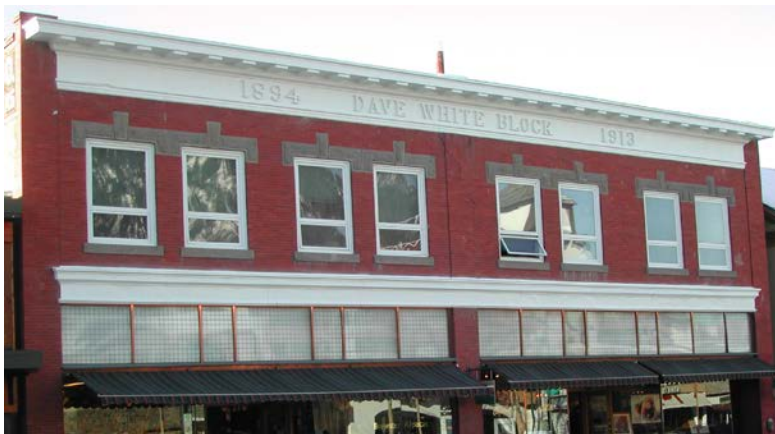
Photo 6 – second storey, beltcourse, clerestory and awning detail

- Retractable awnings (photo 6);
- Clerestory window feature with leaded glass panels above awnings (photo 6);
- Metal beltcourse above clerestory (photo 6);

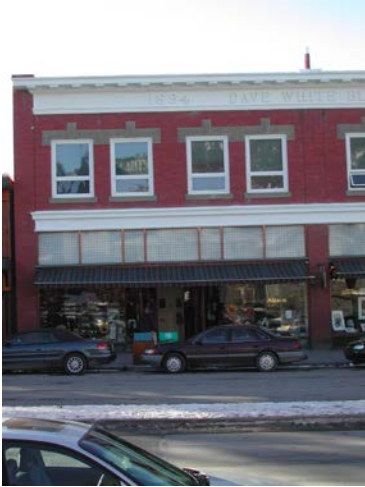
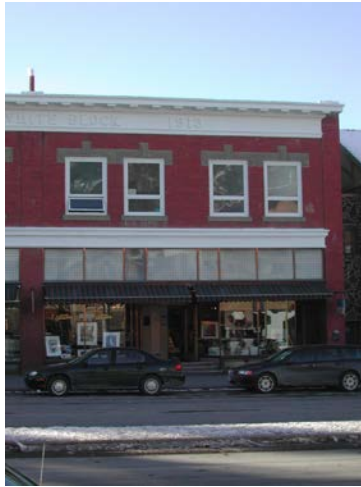
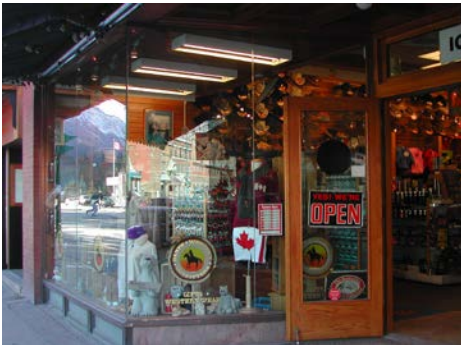
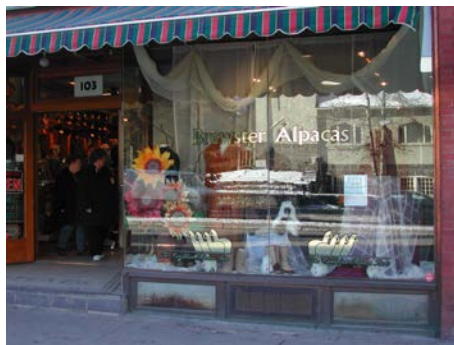
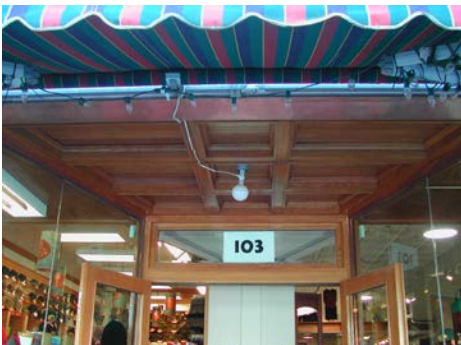
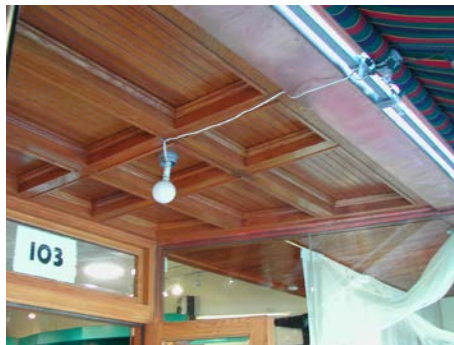
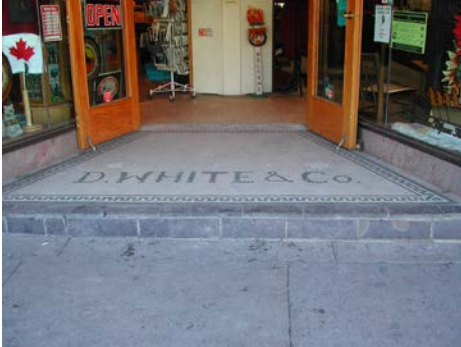
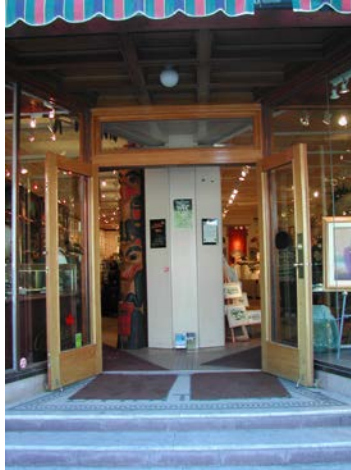
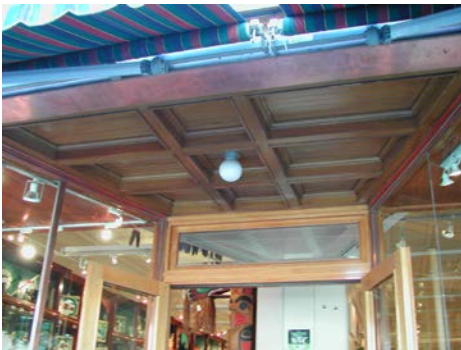
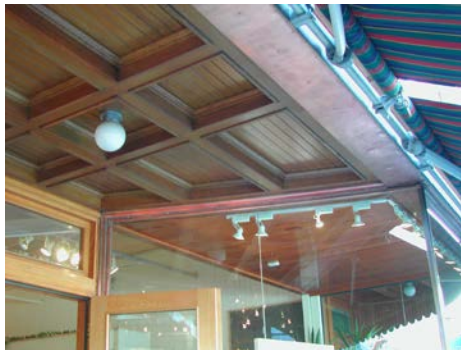
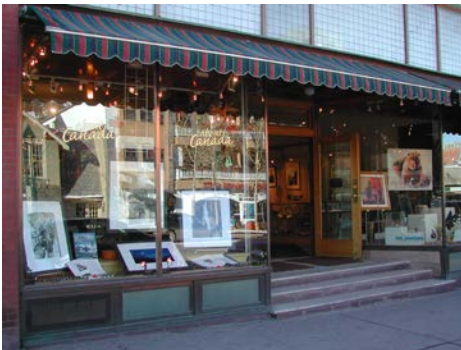
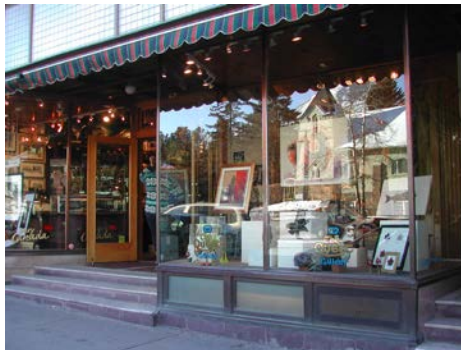
Photo 7 – 103 Banff Avenue storefront

Photo 8 – 105 Banff Avenue storefront

Photo 9 – 103 Banff Avenue storefront

Photo 10 – 103 Banff Avenue storefront

Photo 11 – 103 Banff Avenue storefront

Photo 12 – 103 Banff Avenue storefront

Photo 13 – 103 Banff Avenue storefront

Photo 14 – 105 Banff Avenue storefront

Photo 15 – 105 Banff Avenue storefront

Photo 16 – 105 Banff Avenue storefront

Photo 17 – 105 Banff Avenue storefront

Photo 18 – 105 Banff Avenue storefront

- Symmetrical storefronts with centered recessed entrances, metal framed windows and kickplates below windows (photos 7 - 18);
- Recessed storefront entrances, including the position, number, size and arrangement of doors and windows, with double wood doors, transom window, wood soffit, bronze trim, and stone and mosaic tile floor detail with “D. White & Co.” (photos 7 - 18);

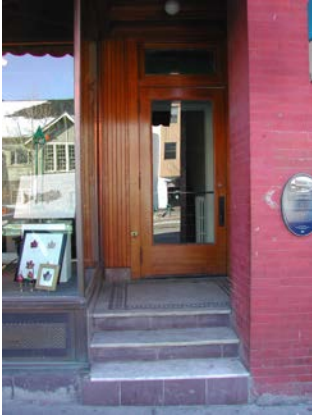
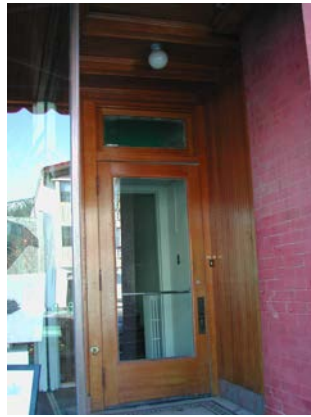
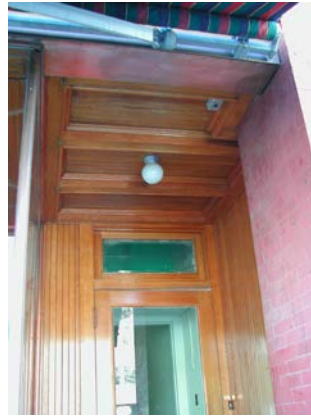
Photo 19 - Side entrance

Photo 20 - Side entrance

Photo 21 - Side entrance

- Recessed side entrance to second storey, including the position, number, size and arrangement of door and windows, with wood door, transom window, wood soffit, bronze trim and stone and mosaic tile floor detail (photos 19-21);

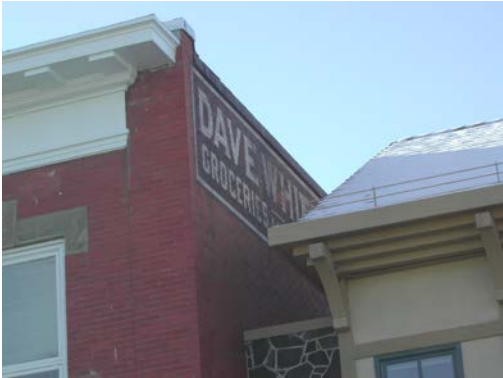
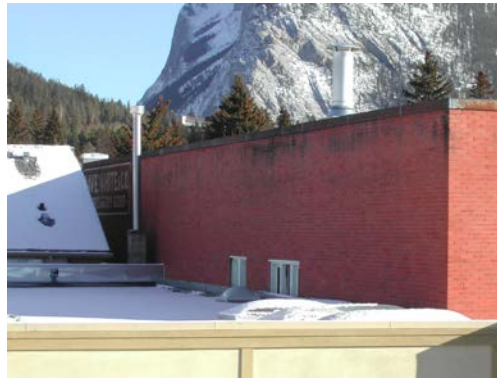
Photo 22 - North façade from Banff Avenue

Photo 23 - North façade from lane

- North façade clad in red brick (photos 22 & 23);
- Flat roof (photos 22 & 23);
- Sign painted on brick “Dave White & Co. Groceries and Dry Goods” (photos 24 & 25)

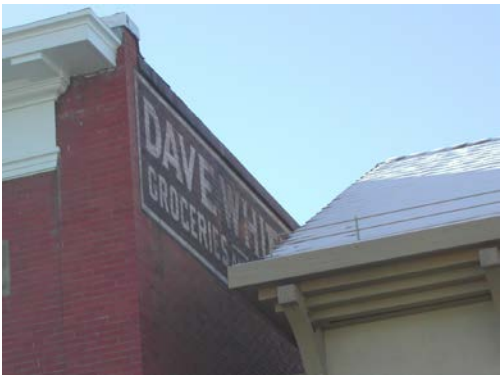
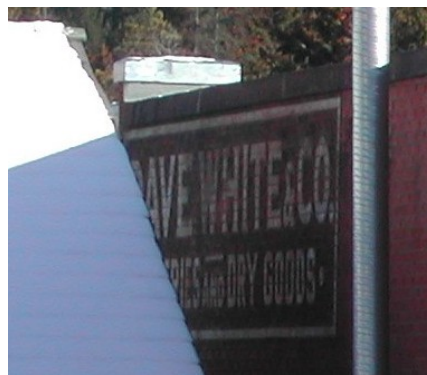
Photo 24 - Sign on North façade from Banff Avenue

Photo 25 - Sign on North façade from lane

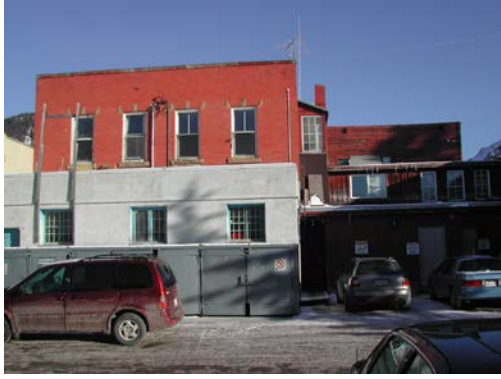
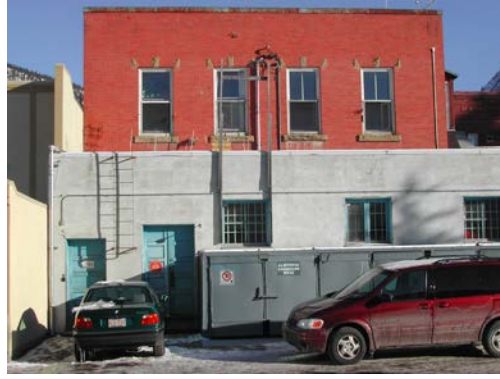
Photo 26 – West (rear) façade

Photo 27 – 105 Banff Avenue - west façade

- Northerly portion (105 Banff Avenue) of west (rear) façade clad in red brick with sandstone pointed second storey windows (photos 26 & 27)
- Series of second storey window openings on northerly portion (105 Banff Avenue) of west (rear) façade, including the position, number, size and arrangement, with sandstone detailing on head and sill (photos 28 & 29);

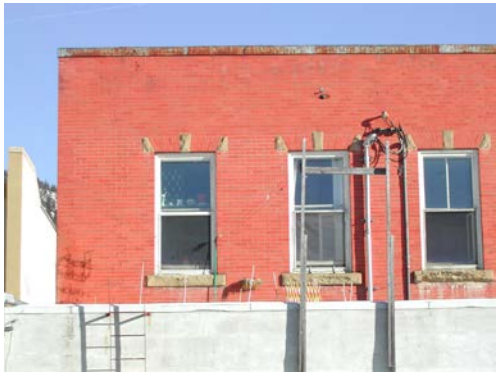
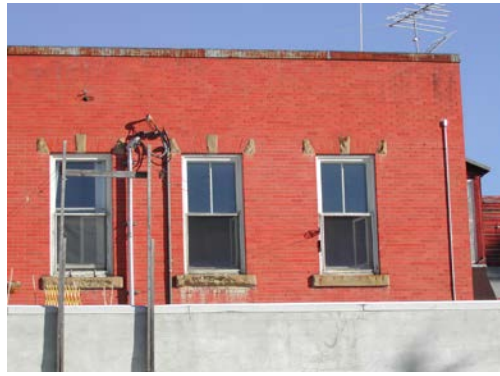
Photo 28 – second storey window detail – rear

Photo 29 – second storey window detail - rear

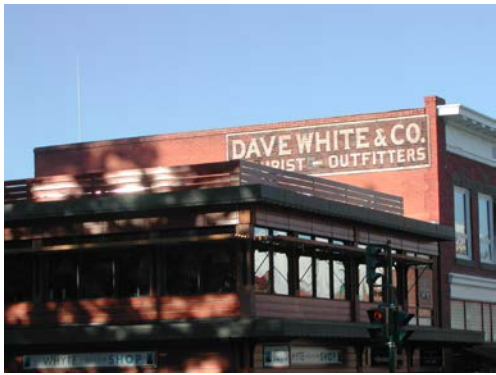
Photo 30 – South façade

- Portion of south façade clad in red brick (photo 30);
- Flat roof (photo 30);
- Sign painted on brick “Dave White & Co. Tourist - Outfitters” (photo 31)

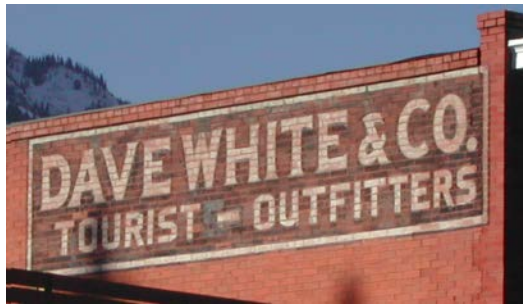
Photo 31 – South façade sign
