BYLAW NO. 218

**Being a Bylaw to designate Tarry-a-while
as a Municipal Historic Resource**

SCHEDULE “A” TO BYLAW NO. 218

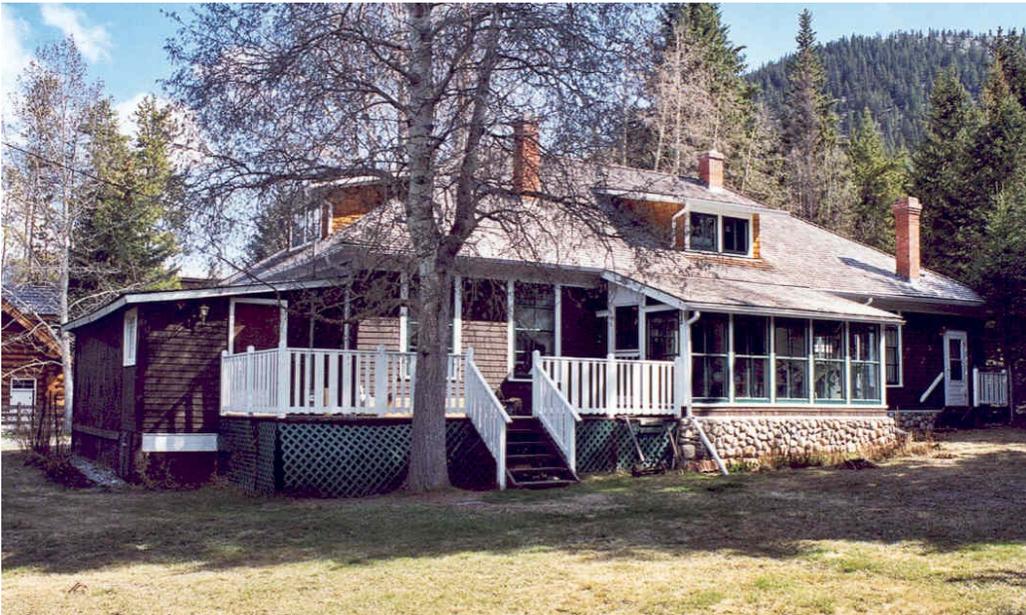
Photo 1 – South façade with enclosed solarium and deck and garage addition on West façade

SOUTH FAÇADE OF RESIDENCE (Wolverine Street) (photo 1)

- South façade clad in cedar shingles with river stone cladding at the base of the wall;
- Position, number, size and arrangement of doors and windows on south façade;
- Steeply pitched hipped roof and shed roof dormer with cedar shingle cladding;
- Position, number, size and arrangement of windows in shed roof dormer;
- Position, number, size and arrangement of red brick chimneys on roof;
- Enclosed solarium addition with shed roof;
- Open deck and railing with staircase to yard;

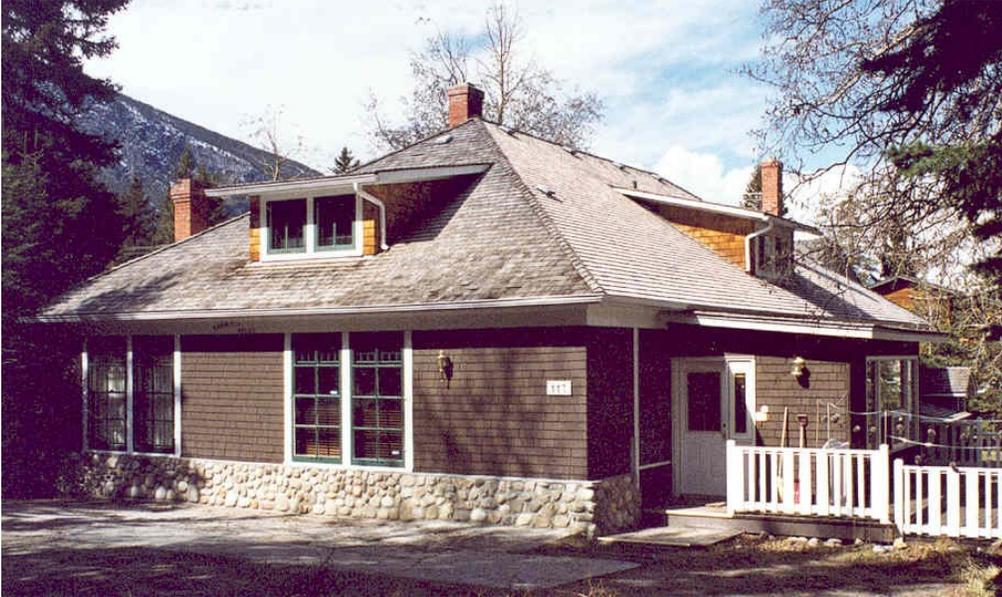
Photo 2 – East façade and porch addition on North façade

EAST FAÇADE OF RESIDENCE (Grizzly Street) (photos 2, 3 & 4)

- East façade clad in cedar shingles with river stone cladding at the base of the wall;
- Position, number, size and arrangement of windows on east façade;
- Steeply pitched hipped roof and shed roof dormer with cedar shingle cladding;
- Position, number, size and arrangement of windows in shed roof dormer;
- “Tarry-a-while” building identification sign at the top of the wall between the windows just below the eave overhang (photo 3)

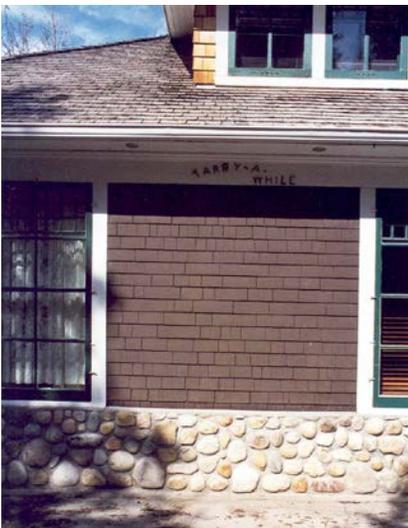
Photo 3 – East façade sign detail

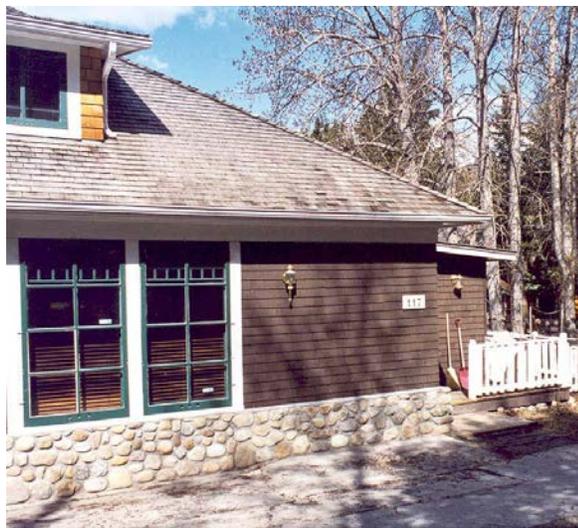
Photo 4 – East façade window, siding, stone-work detail

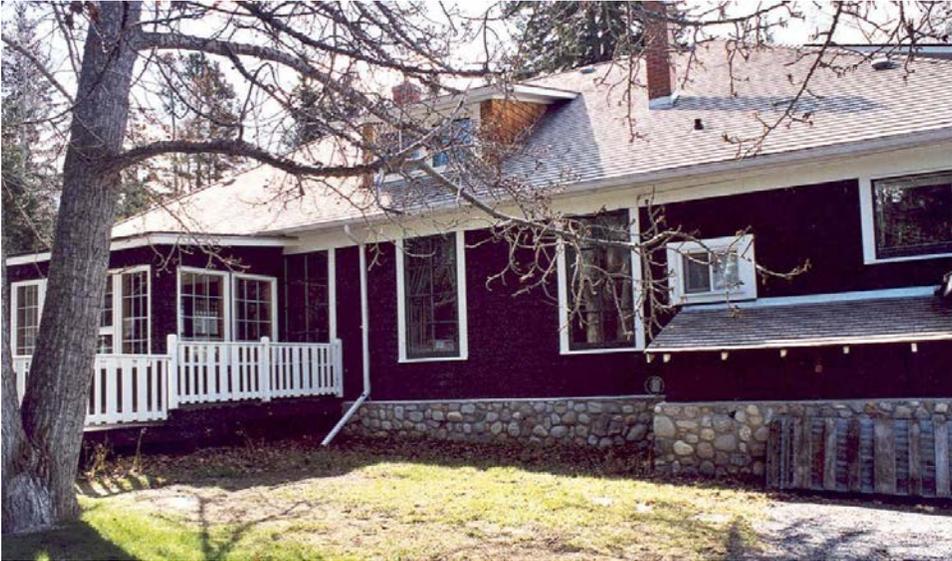
Photo 5 – North façade with porch addition

NORTH FAÇADE OF RESIDENCE (photo 5)

- North façade clad in cedar shingles with river stone cladding at the base of the wall;
- Position, number, size and arrangement of doors and windows on north façade;

- Steeply pitched hipped roof and shed roof dormer with cedar shingle cladding;
- Position, number, size and arrangement of windows in shed roof dormer;
- Position, number, size and arrangement of red brick chimneys on roof;
- Enclosed porch addition with shed roof;
- Position, number, size and arrangement of doors and windows on enclosed porch;

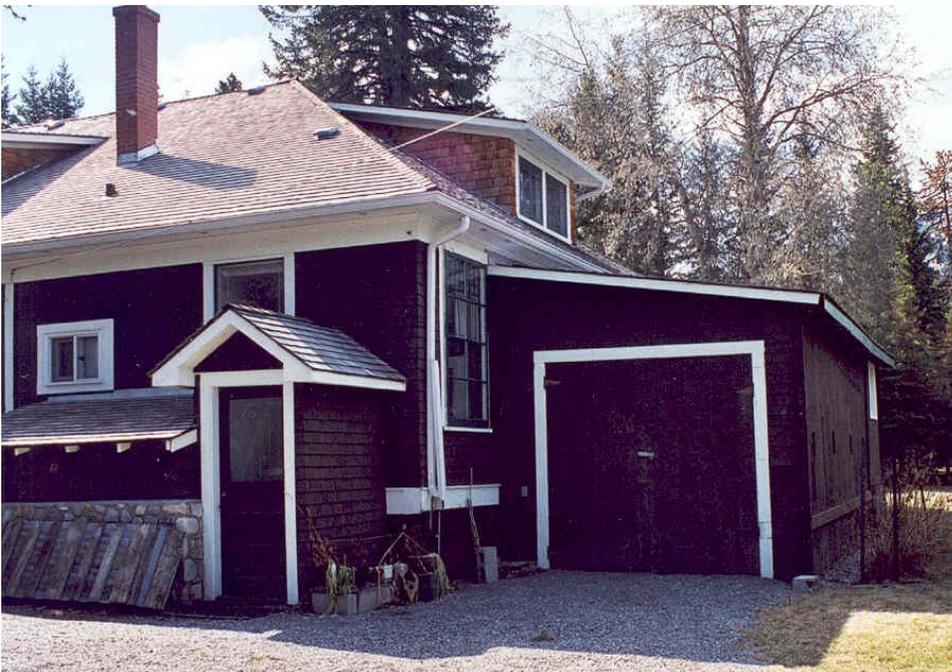
Photo 6 – West façade with garage addition

WEST FAÇADE OF RESIDENCE (Lane) (photo 6)

- West façade clad in cedar shingles
- Position, number, size and arrangement of windows on west façade;
- Steeply pitched hipped roof and shed roof dormer with cedar shingle cladding;
- Position, number, size and arrangement of windows in shed roof dormer;
- Shed roof garage addition clad in cedar shingles and vertical boards;
- Position, number, size and arrangement of doors and windows on garage;
